THAMES RIVER BASIN  
KILLINGLY, CONNECTICUT

OLD DANIELS DAM  
CT. 00168

PHASE 1 INSPECTION REPORT  
NATIONAL DAM INSPECTION PROGRAM

DEPARTMENT OF THE ARMY  
NEW ENGLAND DIVISION, CORPS OF ENGINEERS  
WALTHAM, MASS.  
AUGUST, 1980

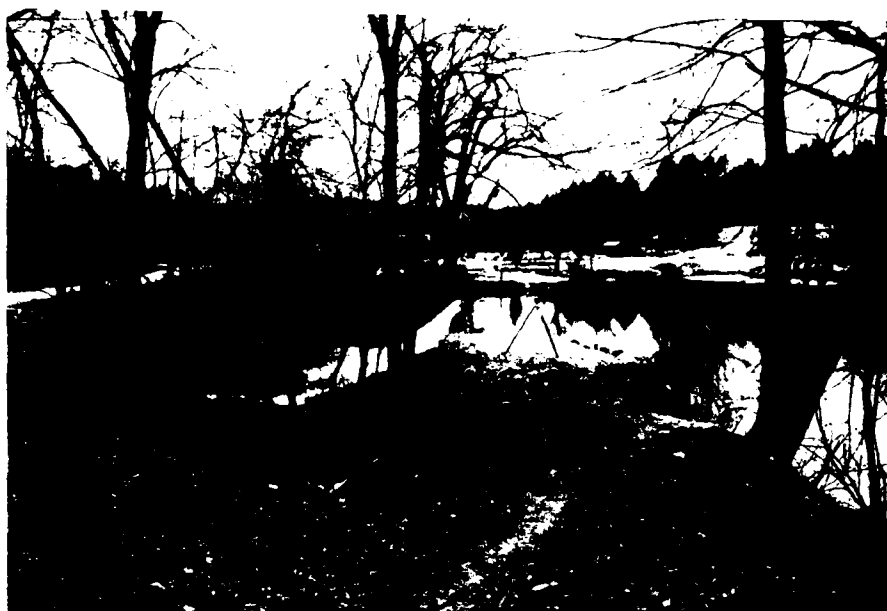
The embankment crest to the left of the spillway is grass covered with a typical crest width of 14 feet. Trespassing has removed the grass cover in some areas (see Photo C-1). Runoff from the crest has caused some soil to wash out from behind the stone masonry wall on the upstream slope (see Photo C-3).

PHOTO C-1 Crest of dam and downstream slope looking from the left dam abutment. Note large trees growing on the slope.

- a. Design and place riprap on upstream slopes of the embankment.
- b. Remove trees growing on the embankment slopes and backfill root depressions with appropriate compacted soils.
- c. Cut all trees growing within 20 feet of the stone walls forming the sidewalls of the spillway discharge channel from the spillway to the Putnam Road Bridge.
- d. Repair all sections of the stone sidewalls forming the banks of the spillway discharge channel where large voids or irregularities exist and where the walls are partly collapsed.

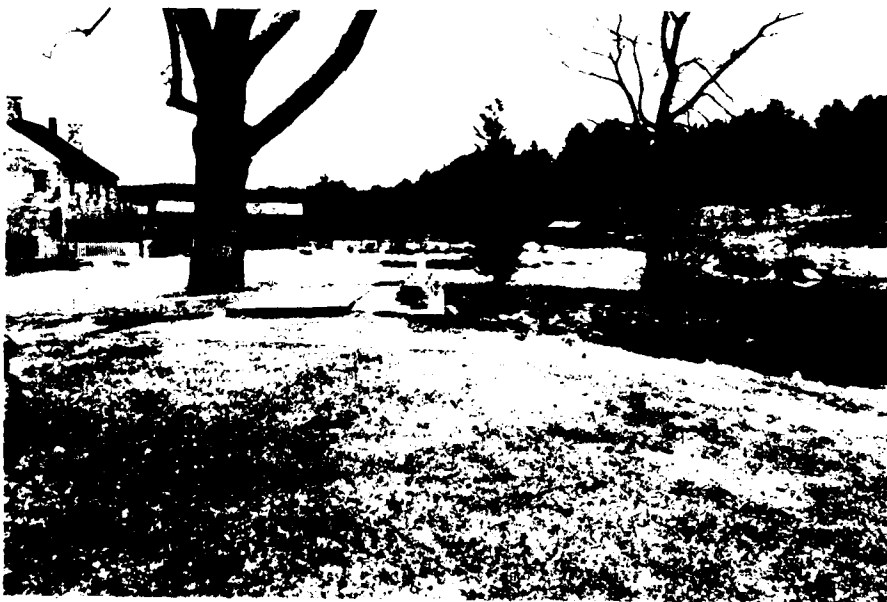
PHOTO C-2 Crest of dam looking from the right spillway abutment.

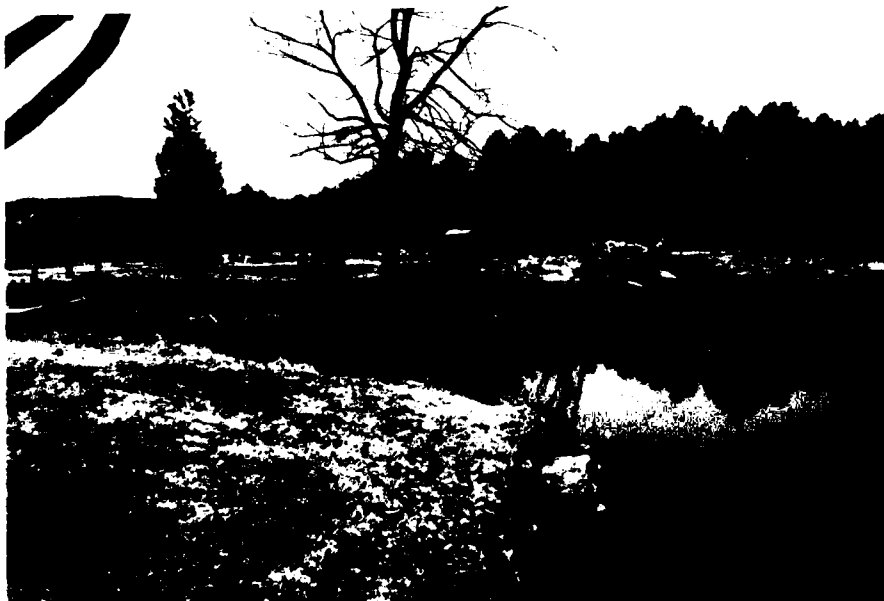
PHOTO C-4 Upstream slope of dam and headrace looking toward the right dam abutment from the right spillway abutment.

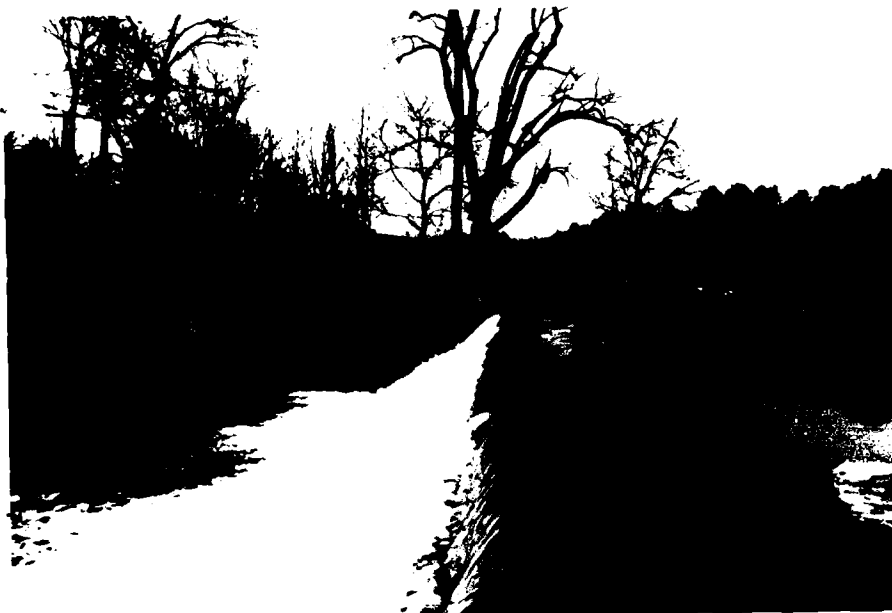
PHOTO C-5 Spillway crest looking from the left spillway abutment.

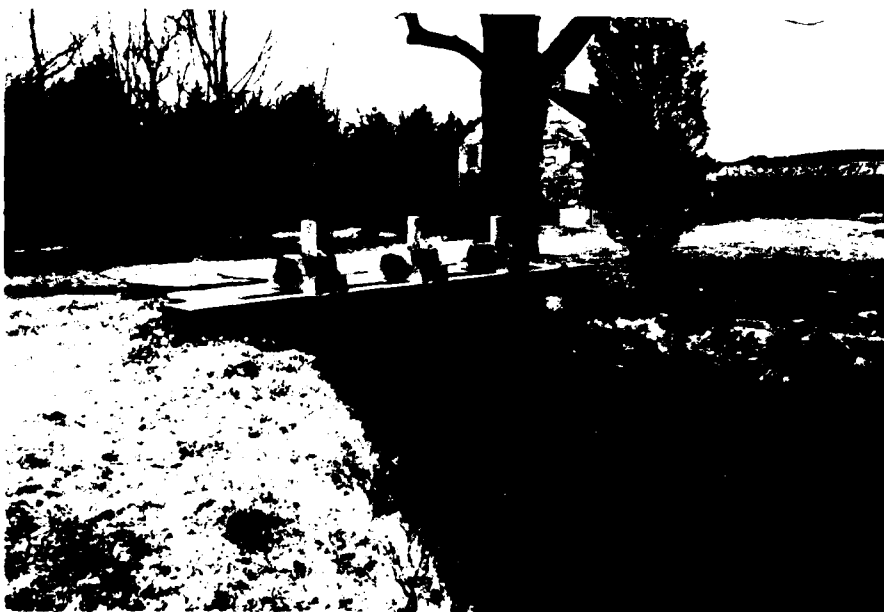
The overall appearance of the conduit (see Photo C-9) is fair. Several areas along the joint between the sidewalks and floor slab of the conduit have been eroded from scour and water was observed to flow or seep out before reaching the outlet. Spalling and cracking of the concrete in the conduit and exposed reinforcement were observed. The left and right sidewalls of the intake structure also showed general deterioration (see Photo C-8). The exposed concrete on the gate structure appeared to be in good condition.

PHOTO C-8 Triple gated headrace.

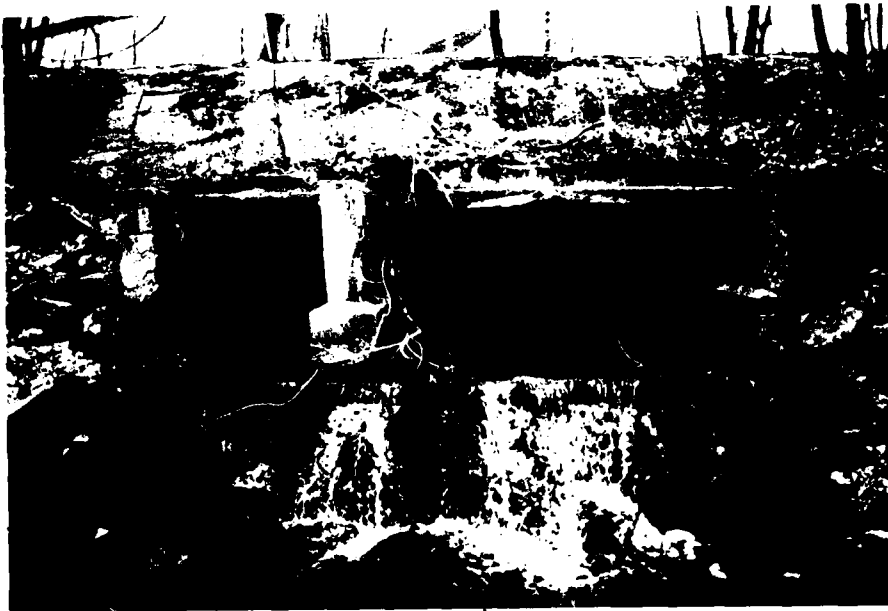
PHOTO C-9 Tailrace outlet chamber.
